Morayfield Deck Collapse Interim Report

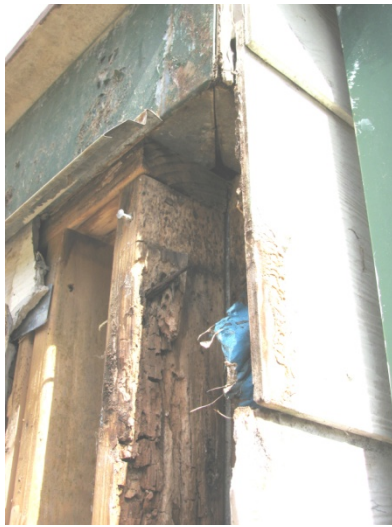
The corner supporting studs are totally missing at the top

The deck collapse was due to totally decayed corner studs (probably untreated radiata) supporting the deck bearer end in the wall frame which in turn was supporting a newer deck added during extensions.

The wall frame is part of a 'room build in' under original deck that occurred during extensions in 1999 with FC 'water proof' deck added over original deck. Deck joist and bearers were cypress with no sign of decay in the cypress deck bearer end etc, or termites. Water entry to corner studs that decayed was due to poor detailing/flashing and failed sealants etc where new FC added over original deck and where the bearer penetrated FC cladding into frame.

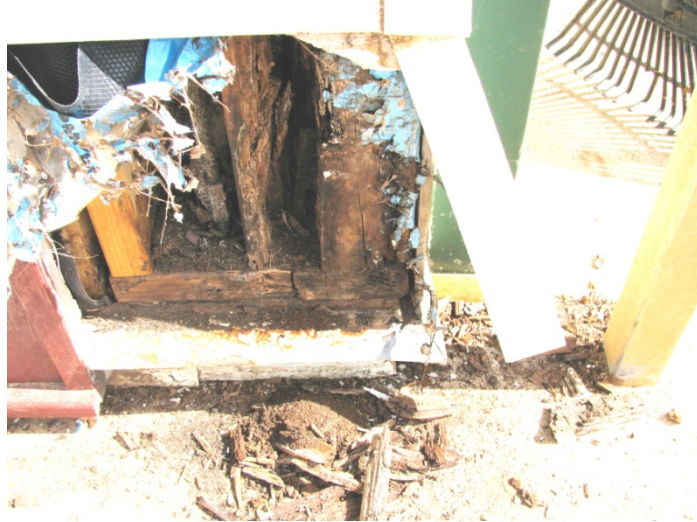
Part of the corner studs can be seen at the bottom
