**Wood Protection (Aust) Pty. Ltd.**  
A.B.N. 95 003 780 872

**Re: Practicality of supplying H6 sawn hardwood for H3 application**

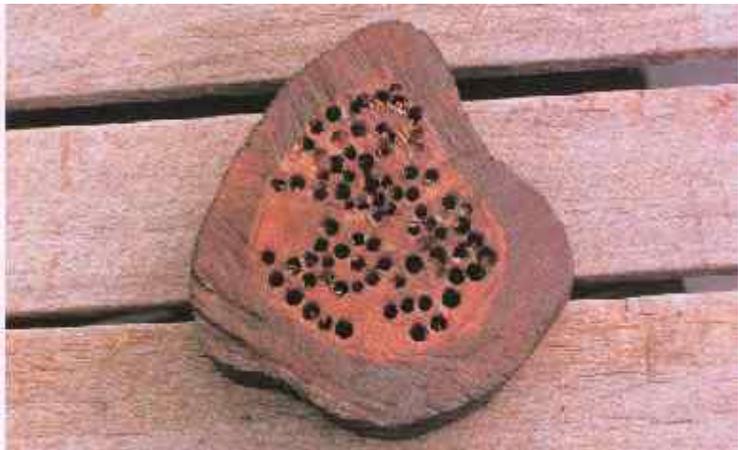
If end entry were possible attack would occur in the unpenetrated inner heartwood only.

A surprising example of this resulted by chance when the double treated (H6) pile off-cut was dropped into the harbour and left after the installation. When extracted and examined eleven years later the Teredo worm attack of the heartwood is clearly illustrated in the adjacent photograph below. If the sapwood band were not present i.e. as in sawn timber, the H6 specification would not have been achievable.
