May 2012 Newsletter

Identify and Assess That Defect

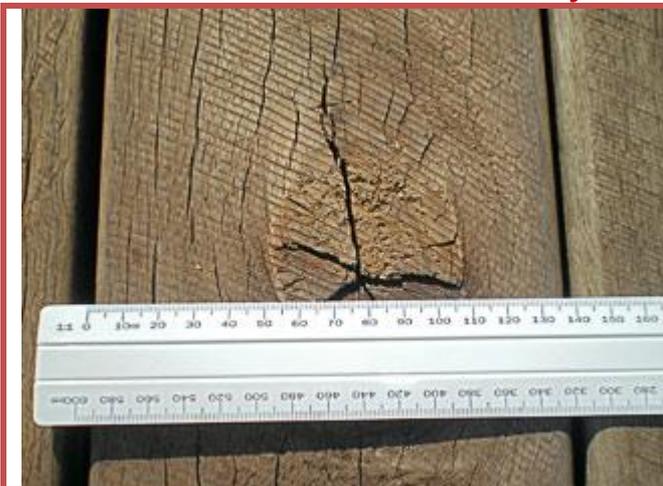
Sound Knot, At least it was when it was cut and that is how you have to imagine it when you grade it, not as you see it now, It measures about 60mm across a face of 145 when laid, i.e. 40% of the face. The allowance for knots in AS2082 in unseasoned timber for the different stress grades is

Grade	Ironbark	Spotted Gum
F22	36mm (1/4)	21mm (1/7)
F17	48mm (1/3)	36mm (1/4)
F14	54mm (3/8)	48mm (1/3)
Deckwood	18mm (1/8)	18mm (1/8)

The knot illustrated meets no structural grade, even the lowest conceivable, and will continue to degrade.

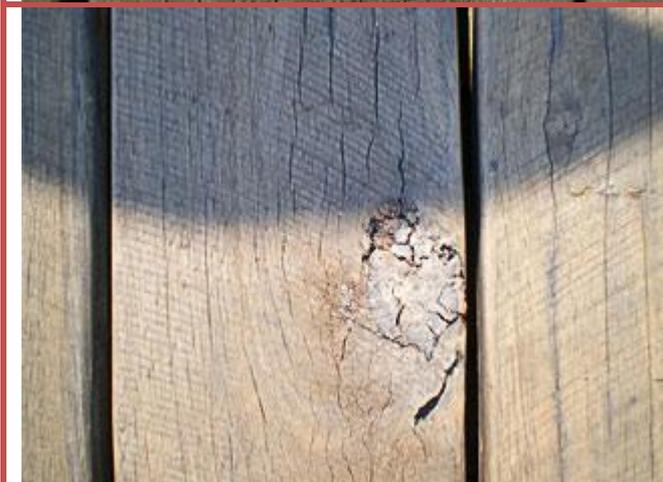
Unsound Knot, Treat as knots as in the table above. There is a pocket of resin associated with a knot. Over time the resin will degrade and wash out and leave a trap for heels

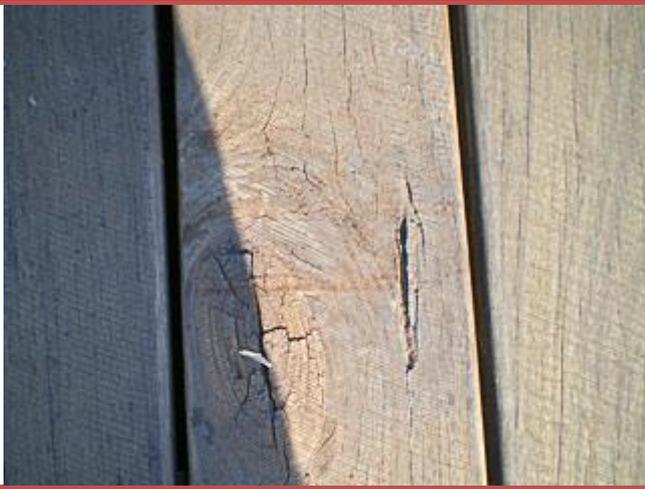
Combination Defect. When grading these defects the width of the knot is added to the width of the shake. This combination defect is over 50% of the piece

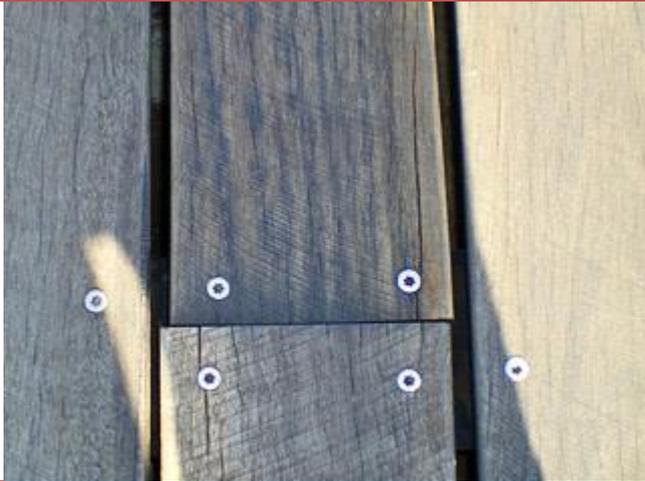
End splits near screws. This splitting is a design, not a quality issue. Our Deckwood Design Guide describes best practice on page 3. There simply is not enough room on a single joist to join as you would do lineal domestic decking that is nailed. We recommend a double joist with 150mm between the joists and laying the deck with a 6mm gap between the ends of the boards to prevent moisture ingress. See

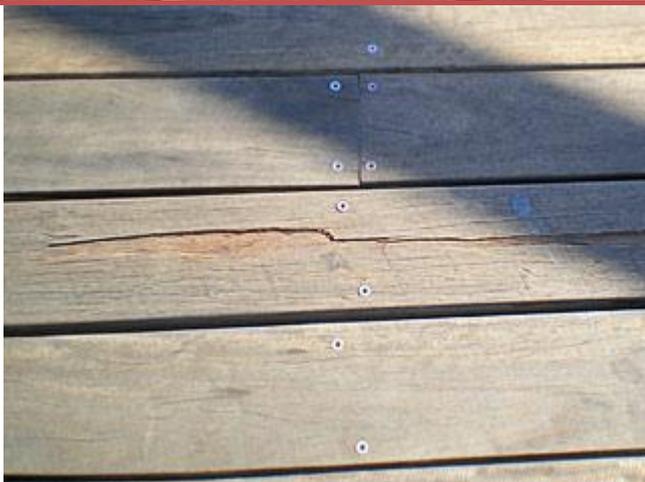
Shelling Out. Shelling out occurs when there is delamination between the growth rings. These have sharp splinters that have to be made safe as soon as they are seen. This example of delamination, which is going across the boards was evident at the time of production and should have been docked out

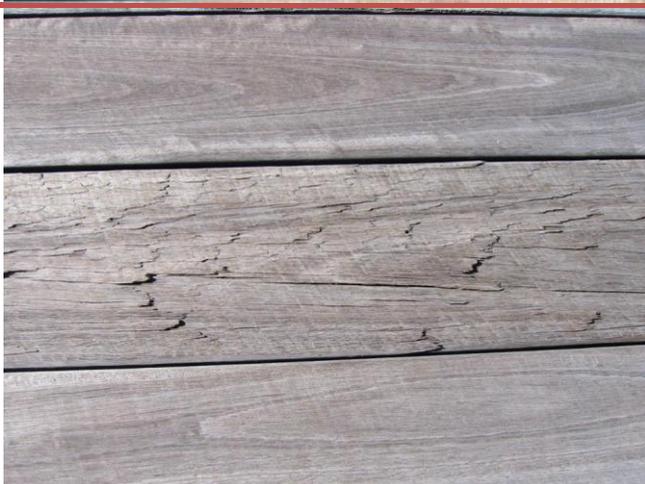
A different form of shelling out was also visible but unfortunately I did not photograph it. Occasionally some boards shell out along the length and can raise sharp edges. These are not evident at the time of production and laying but occur soon after, You simply have to look for them, make them safe and replace the board. This can be in the range of 1 to 3% of the total. The practice with Deckwood is to supply replacement timber but not install them, No one else replaces to my knowledge.

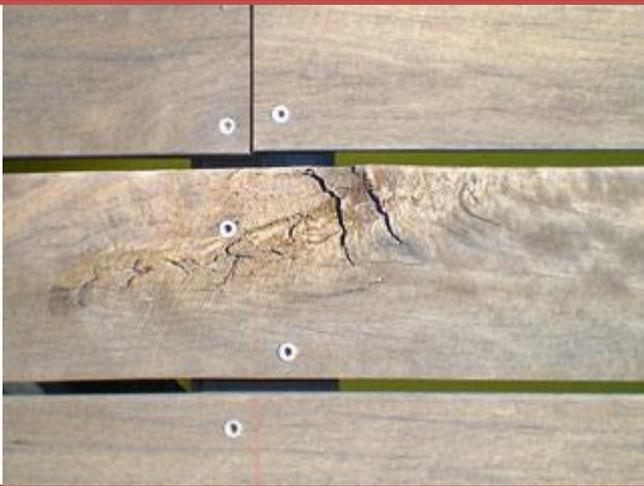
Cross shake (fracture) in conjunction with a knot. Fractures are not permitted at all under AS2082. This defect covers over half of the board. Again this meets no F rating.

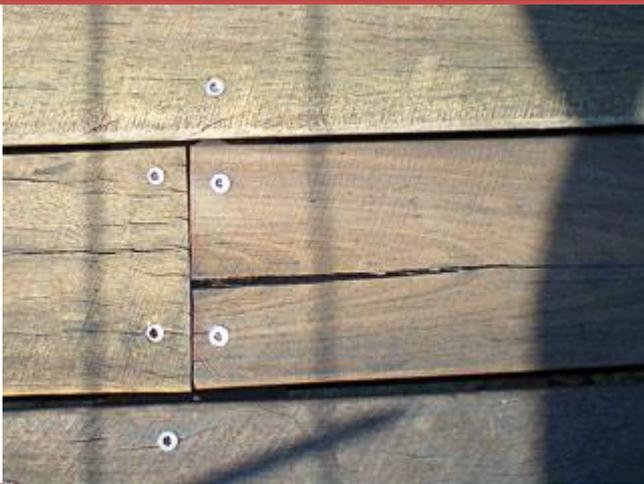
End Split. The end split allowed under AS2082 is 100mm. This split is at least 300mm but probably was not like that when produced. The way this piece has split is reminiscent of the behaviour of high shrinkage timbers that are restrained with screws. By not nominating the species and ensuring that you receive what you ask for, you can receive timber that shrinks up to 13%. Deckwood only uses species that have 6% shrinkage.

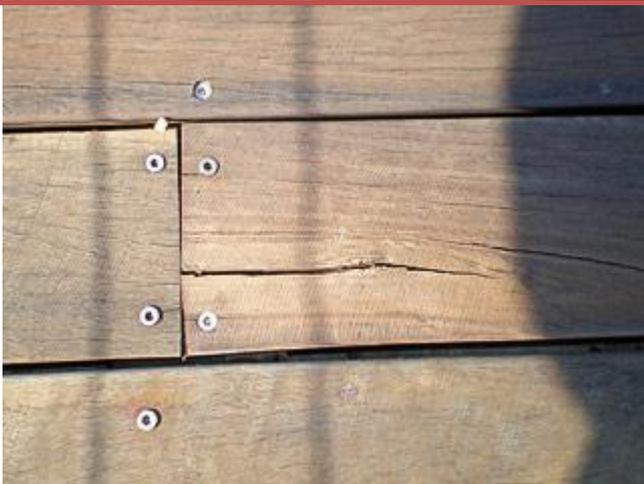
End Split Associated with Heart. This is a hard one for the uninitiated. Notice how the timber down the split is a lighter colour and there is a small knot in it. This is characteristic of heart. AS2082 forbids any heart at all but in reality the decking can carry a touch on the back. But definitely none on the front.

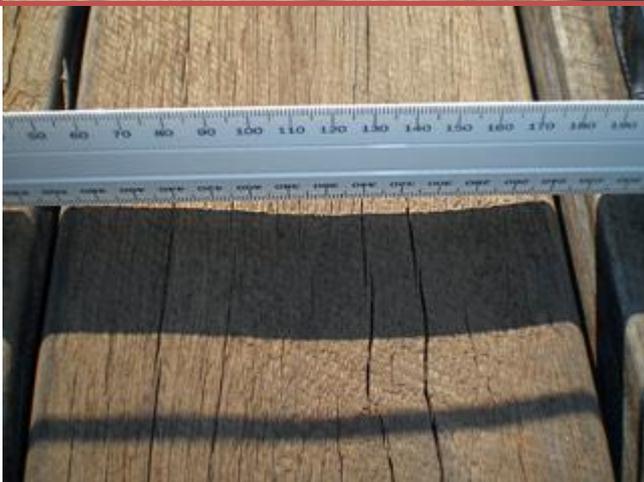
Cupping. The decking was 145x35. In my first email newsletter (July 2009) I described how to minimise deck cupping and it is all down to width to thickness ratio and 145x35 does not work. If it must be 145 wide then it must be 45 thick. If it is 35 mm thick then it is no more than 120mm wide. We used to make 145x35 a long time ago until we had two claims against it. One we had to pay on, the second was where the client knowingly used it against our recommendations. We refused to pay on that claim. That was enough. We will not make a 145x35 Deckwood now.
