February 2014 Newsletter

Written by Ted Stubbersfield

For Infrastruxion Pty Ltd

[Different Ways to Prepare Rails](#)

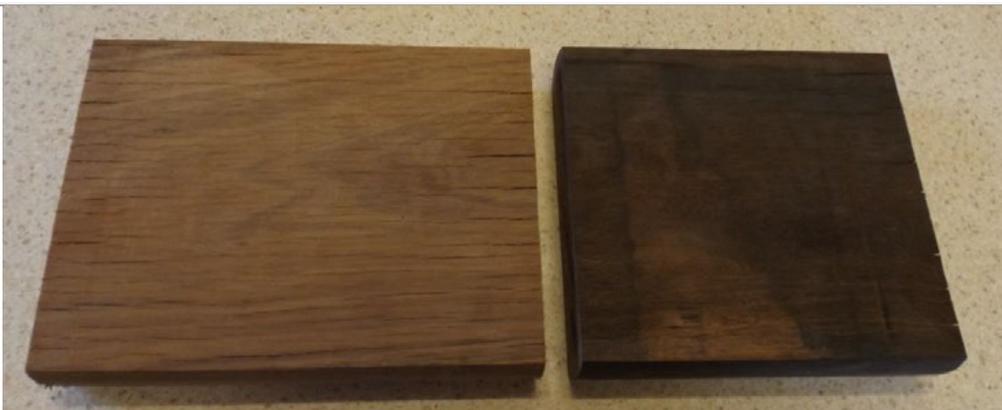
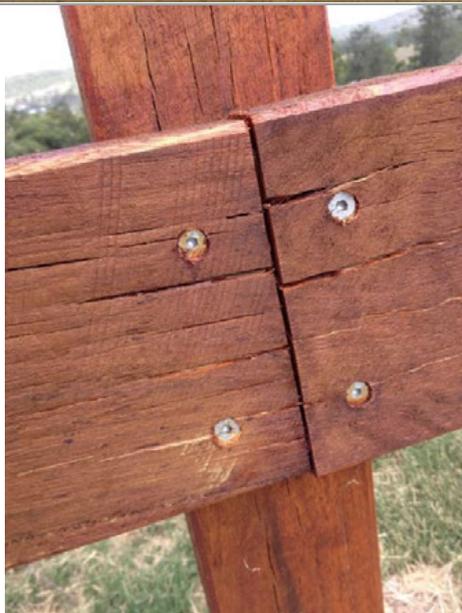
The two images above show three ways a timber traffic barrier rail can be processed. The rails in the top image show two versions of our 190x44 Continuous Rail. The rail on the left shows one of our rails that was treated with Tanalith E to H3 and then dressed. The rail on the right was dressed then treated with Tanalith E. The second rail has a uniform brown colour from the preservative. The timber rail in the lower image looks untreated and has not been dressed. It is not as pleasing to the eye as either of the rails above refer to last months newsletter for an image of a whole fence with the dressed after treating option. Now there is not a big difference in the timber specification but there are differences, it is not dressed for a start and we use better species as well.

So, with your rails you can continue in your old ways or you could specify 190x44 Continuous Rail by Outdoor Structures or its licensees in either treated after dressing finish or dressed after treating finish. The standard lengths are 3.6 m and 2.7 m. Other sizes are available. Talk to us about your needs.

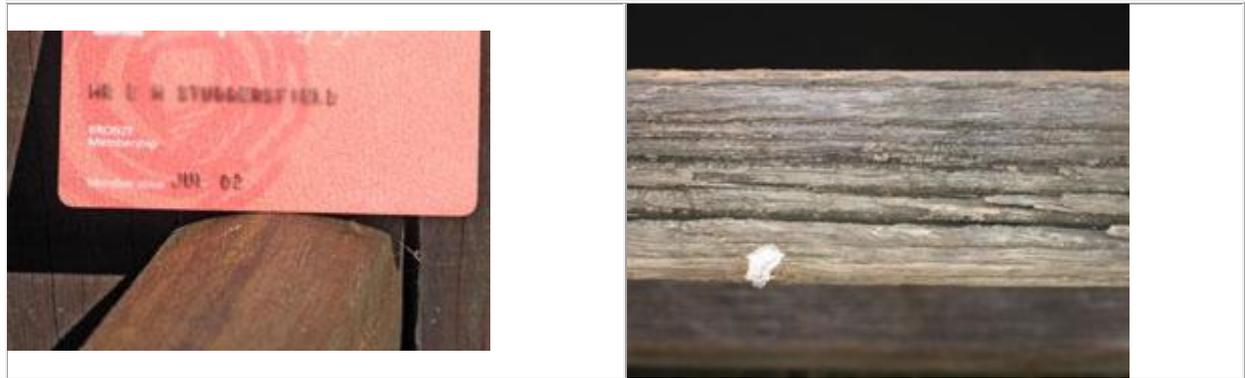
One thing we noticed is the need to shed moisture on these rails even though they only have a small top surface area. The rail on the right is a 20 year old piece from one of my bridges. I thought, I could do better and after taking that image always ensured that the tops of our rails had a radiused top surface. Not enough years have gone by to tell you it is a great success but it should perform better.

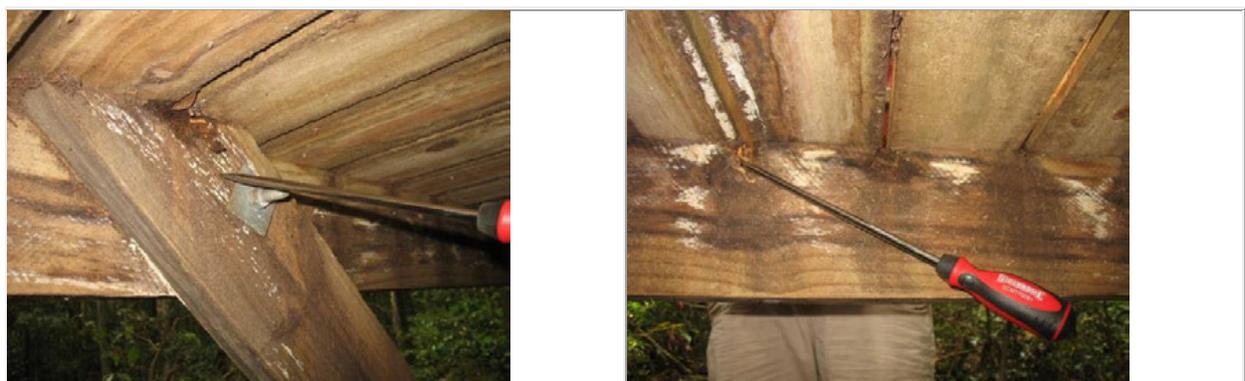
These two images from a recent consultancy (used with permission) show examples of where it is not so clear. When looking at the white flecks, you cannot tell if we are looking at patches of vegetative fungal growth; (not spore-forming) or a flat fruit body (reproductive structure; spore forming). When you see the presence of this type of material on the outside of timber you should test the affected areas to see if it is just something on the surface or a symptom of internal decay. On the image on the left the decay was clearly evident once I started trying to push the spike into the treated pine brace. The brace has exposed end grain which allowed moisture to enter which then caused it to decay. Once the decay started, it then spread into the joist to which it is bolted. The added lesson here is don't clutter your design and avoid exposing end grain, especially in pine.

In the October 2012 newsletter I gave a summary of the coroners report on the deck fatality at Yeppoon where a young baby died. There, the builder who was called in to inspect the deck did not understand the significance of fruiting bodies that could be seen on the underside of the decking. - [click here](#) for a link to the October 12 newsletter. Fruit bodies of decay fungi are often leathery-looking brackets or they can look like mushrooms and the colour ranges from white to brown. Spores are released from gills or pores. You would

think that it would be easy to spot and identify something so obvious.
