OUTDOOR STRUCTURES

March 2015 Newsletter

[Standards You Can Drive a Bus Through](#)

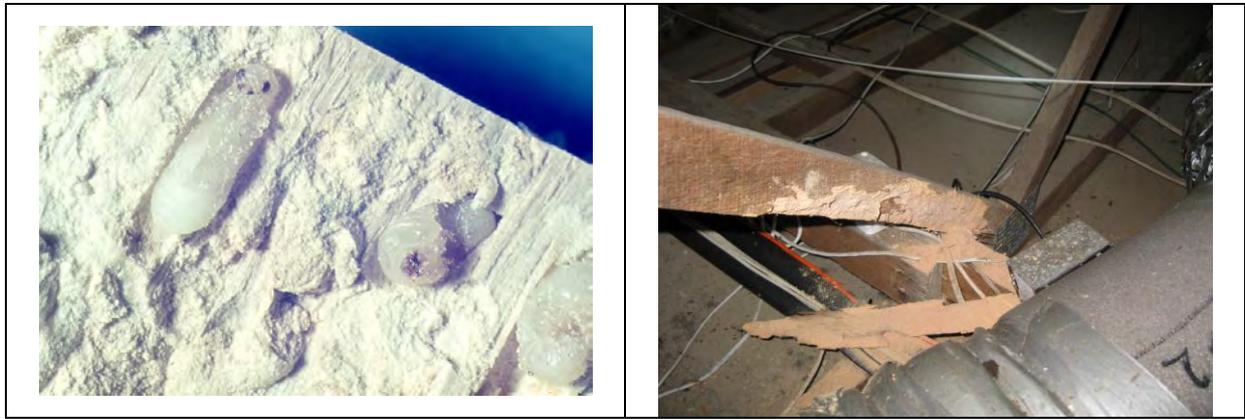
AS 2082-2007 has a limitation to the amount of lyctus susceptible sapwood that can be supplied in any given piece timber which for most grades is 20% of the cross sectional area. This was overridden by Queensland and New South Wales in their respective timber utilisation acts which would not allow any susceptible sapwood to be supplied. These were acts with real teeth and because of that we did not breach them. Then in their wisdom both governments repealed their acts and the protection that went with them. The image on the right probably now meets the requirements of F14 in Queensland and New South Wales. Are you happy to specify such material?

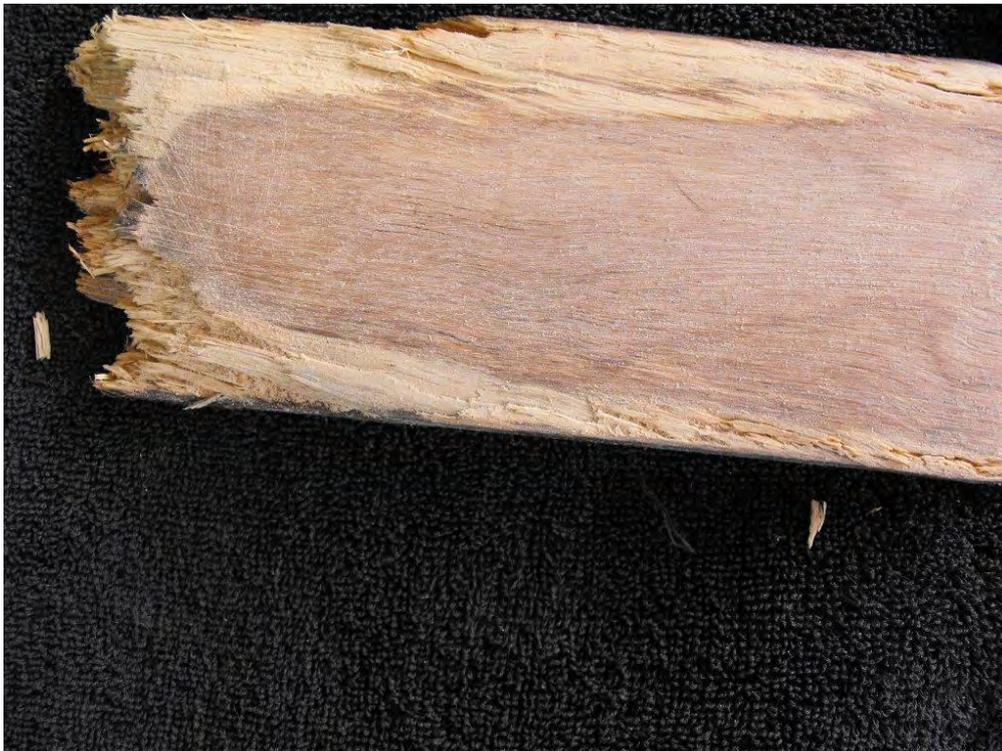
Not all sapwood is lyctus susceptible and doesn't get turned to powder from the larvae but that does not change the fact that it is not durable if used externally. The image above shows decay in blackbutt sapwood. When the piece was freshly cut the sapwood is clearly visible but as it dries it is hard to tell sapwood from heartwood. Used internally as an exposed beam it will not give you any problems. Move it outside and had it been fitted into a joist hanger the potential for trouble is enormous. Now AS 2082-2007 has no limitation on the amount of sapwood if the timber is not lyctus susceptible.

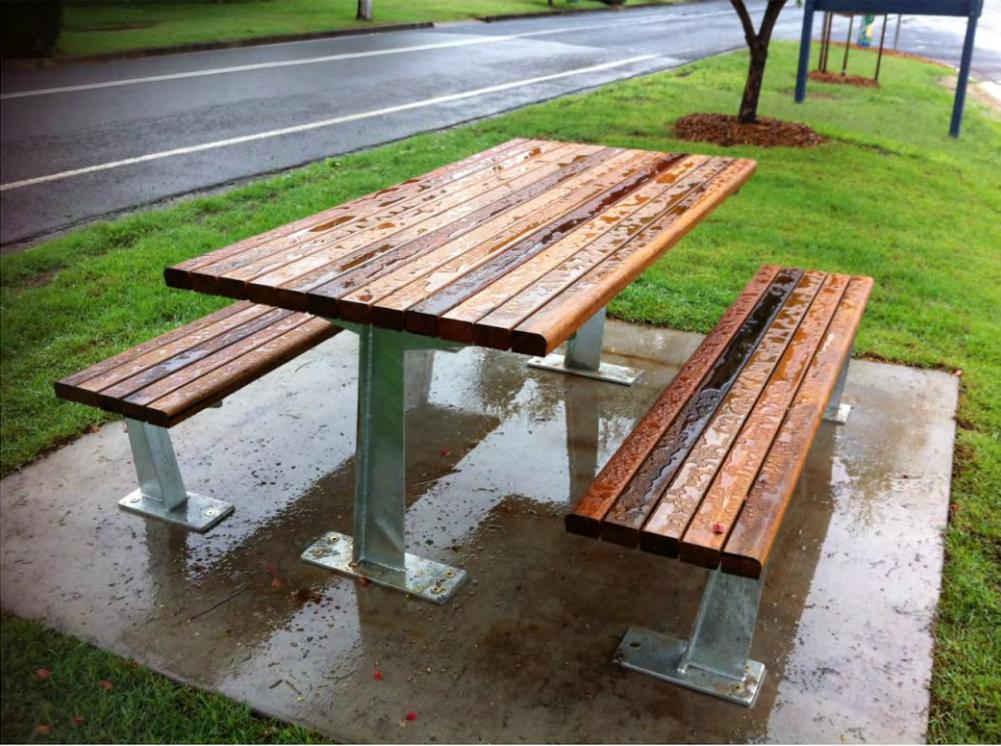
Keith Smith on 0403 601 030. Avoid the last minute frenzy. In case you had not noticed, the Flinders barbecue table shown above would grace any council park.
