OUTDOOR STRUCTURES

September 2013 Newsletter

[Case History Showing Unsuitable Decking](#)

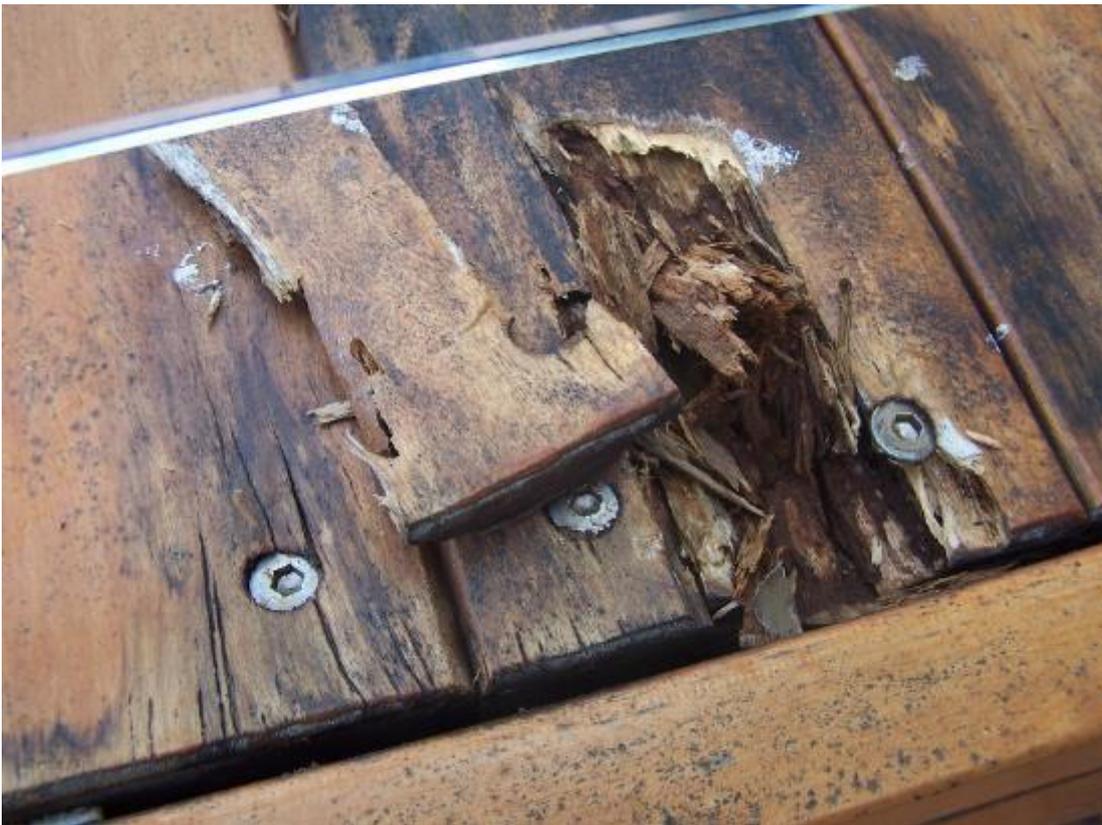
The image above shows Garo Garo marketed as Pacific tallowwood after 4 years in north Queensland!

There have been some large decks built from Pacific tallowwood that have failed in a short time which caused the review of the New Guinea data. Tallowwood on the other hand is one of Australia’s finest timbers as it is dense, durable and strong. It is a durability Class 1 timber both in and above ground. A kiln dried piece of tallowwood, suitable for decking, is rated as F34 By calling something "Pacific tallowwood" could immediately bring up the connotations of all that is good about tallowwood. But call it by its common trade name, garo garo, and you get an entirely different picture. This is how they compared before the downgrade in durability and density.

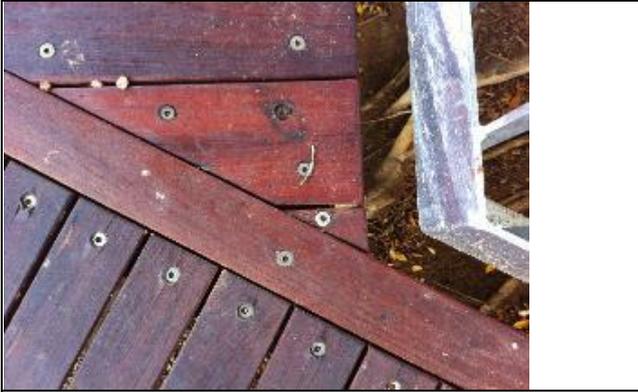
Figure 1. Dressed Finish

Slip resistance of boardwalk decking is discussed in my **Deck and Boardwalk Design Essentials Guide**. The deck also has to meet the requirements of the disability code and it is the responsibility of any grader to point out that regardless of what is written in AS2082 the timber is unfit for purpose. My testing showed that dressed face decking produces a deck where people are highly likely to slip. But acquiring this knowledge is not something that requires

expensive testing in a laboratory, all that will do is give a value to its inadequate performance. Any experienced miller knows this as they would have had trouble with the inner boards of packs of dressed decking slipping out as they delivered to steep sites in the days before webbing straps. This is where the miller should be talking to the specifier and giving firm advice as he has the knowledge to speak authoritatively. This dressed face would be bad enough but the deck is on a slope compounding the problem.

My own practice was to refuse to supply dressed face decking unless it was under a roof. The potential for litigation is just too high. Unfortunately the profile is a copy of my Deckwood. People copying most of the aspects of my profile without understanding what we did led to some very poor timber structures being built. - e.g. see the May 2012 newsletter http://www.outdoorstructures.com.au/pdf/osa_newsletter_05_12.pdf When grading timber you grade a batch of timber. If you are grading timber intended for a set of roof trusses that is reasonable. The standard allows for 5% of the batch to be out by one grade and this is all accommodated in the design software. This approach is also fine when you are grading joists and bearers in a boardwalk but it is not acceptable for grading the decking. **Every** piece must be suitable for its purpose as it is individual boards that can cause injury and litigation.

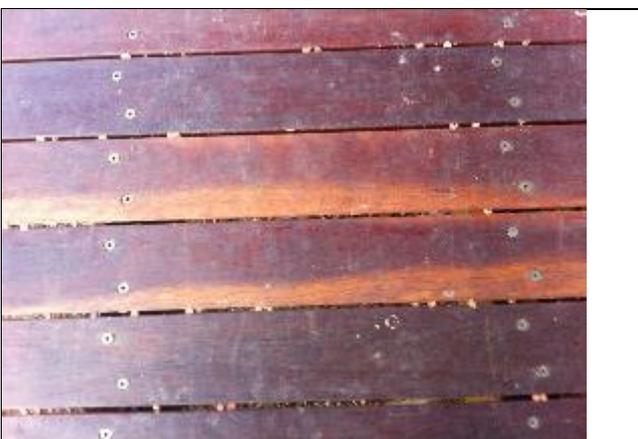
Figure 2. Untreated sapwood on face

The heartwood of ironbark is Durability Class 1 In Ground which makes it suitable for decking. The sapwood is Durability Class 4 for both In Ground and Above Ground applications. The sapwood of ironbark is basically as durable as the sapwood of pine. As the sapwood is not lyctus susceptible there is no restriction to the amount of sapwood even in Structural Grade 1 so this decking meets AS2082. If it was lyctus susceptible it would be restricted to 1/10th of the cross section and 1/3rd of the width of the

edge on which it occurs.

As far as fitness for purpose is concerned, this sapwood is going to decay and do so fairly quickly. This will leave the surface of those pieces where the sapwood has decayed below the surface of the adjoining boards. At 6 mm difference it represents a trip hazard under the disability code and the boards are unfit for purpose. This is why timber preservation is important even though it may have little effect structurally.

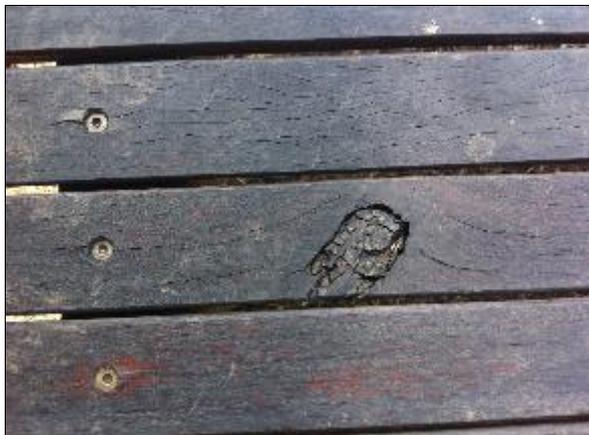
Figure 3. Large knots.

The decking was 120x35 mm. In Structural Grade 1, the largest knot should be more than $1/7^{\text{th}}$ of the face or 17 mm. There were many boards that had knots far in excess of 17 mm. Structural Grade 4 (F14) would only have allowed the knot to be 45 mm. There were many knots far larger than this meaning the timber did not meet any structural grade at all. When grading, only 5% of boards are allowed to be out of grade and then by only one grade. Nothing then should exceed Structural Grade 2 with a

knot not exceeding $1/4$ of the width or 30 mm. This knot virtually covers the whole face and a structural failure of this board is likely.

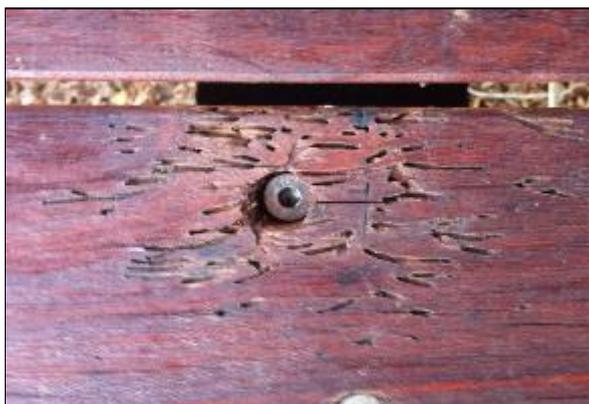
Figure 4. Termite activity.

We can see in Figure 4 that the decking screw which is in the centre of some termite damage has just continued to drive deep into the timber. This will allow water to enter the galleries and the damage will continue to get worse. The depth of the termite attack should have been able to have been seen on the edge and it is graded as not want and wane which for Structural Grade 1 is $1/10^{\text{th}}$ of the cross section.

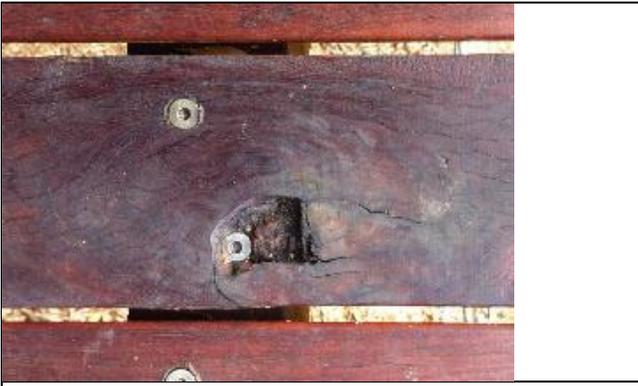
Figure 5. Gum pocket.

It is sometimes difficult to identify the defect you are trying to grade. Figure 5 is an example. Is it a gum pocket? There is gum in it. Is it an unsound knot encased in resin where the knot has fallen out? Irrespective of what it is you would grade/measure this as a knot. It is too large for F27 but probably makes F17. Despite being able to give it a grade it is unfit for purpose as this represents a trip hazard with high heels. Further moisture will sit in this hole and the

defect will deteriorate even further.
