October 2013 Newsletter

New Life for an Old Timber Bridge:
Retrofitting Boundary Road Queensland Rail Railway Overpass Bridge
(Not a paid advertisement)

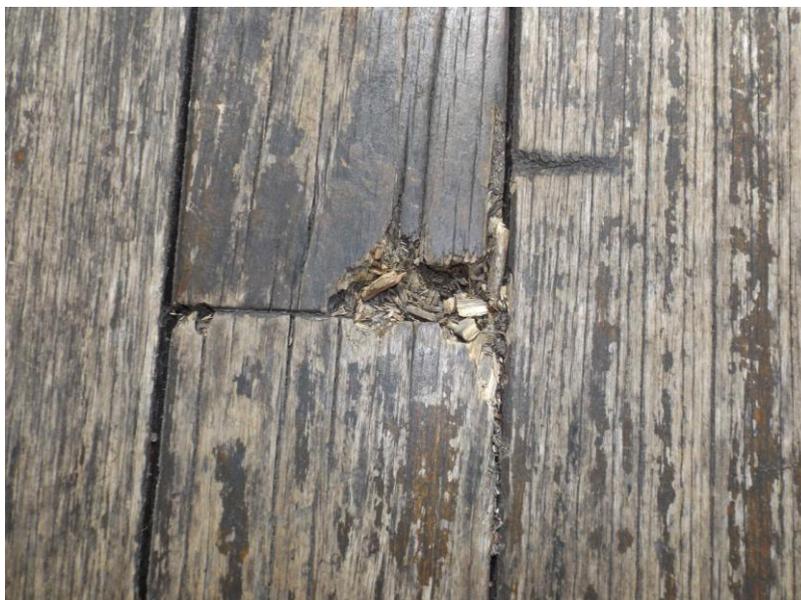
F17 Vic. Ash used as decking in Queensland

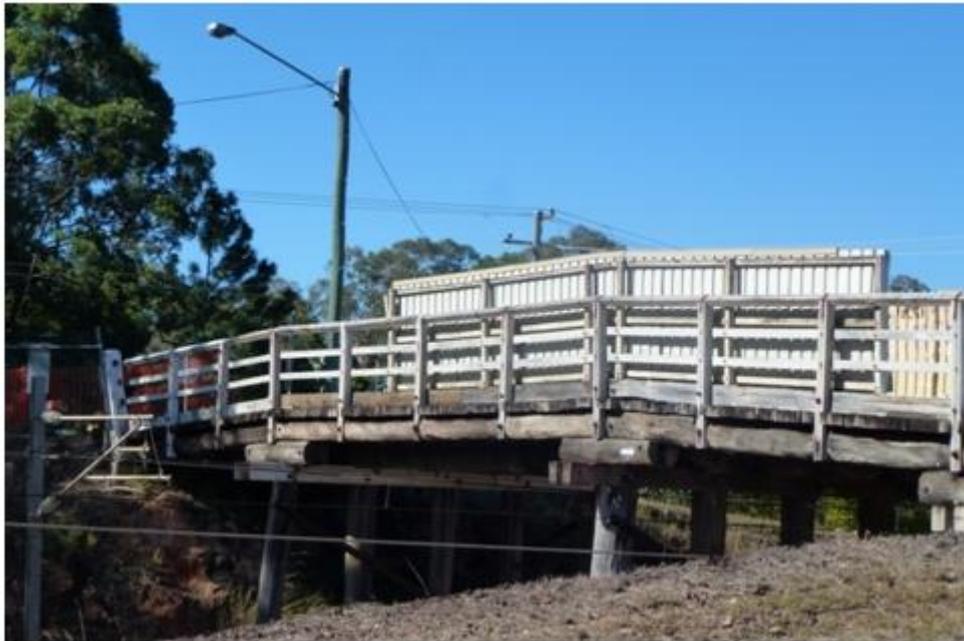
The old Boundary Road Bridge was so dilapidated and unsafe that it had been closed to all traffic weighing over 2 tonnes. The bridge was limited to one lane of traffic manned 24 hours a day by traffic controllers.

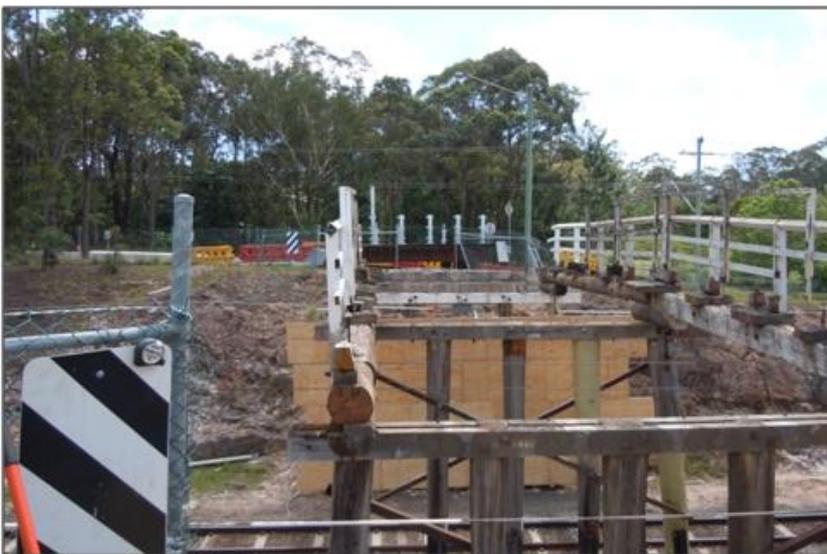
The bridge superstructure was stripped off to prepare for installing the replacement spans and the piles were reinforced with high-strength fibre wraps.

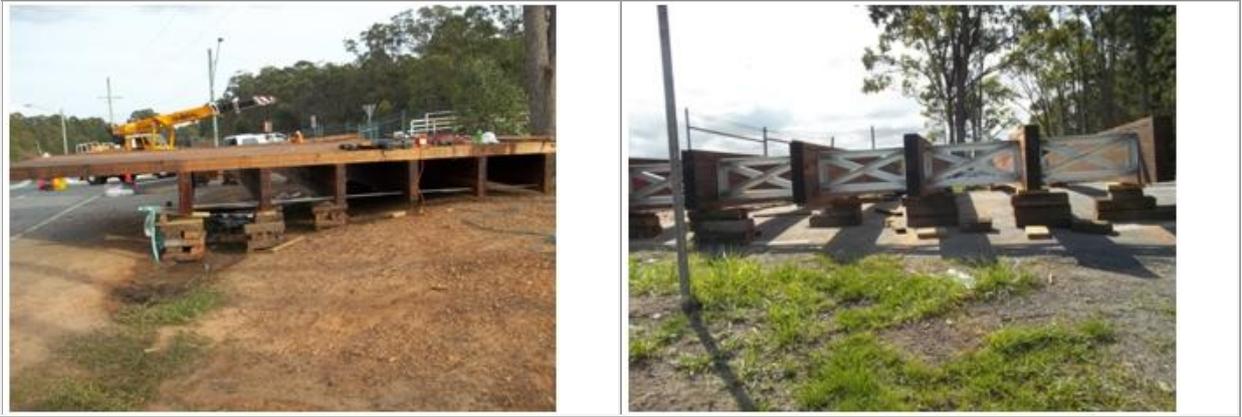
The spans were pre-assembled in a staging area adjacent to the bridge to limit the time the rail traffic would be affected. The girders, cross braces, and deck panels for each span were assembled on the ground and then lifted into place on the existing substructure as a single unit.

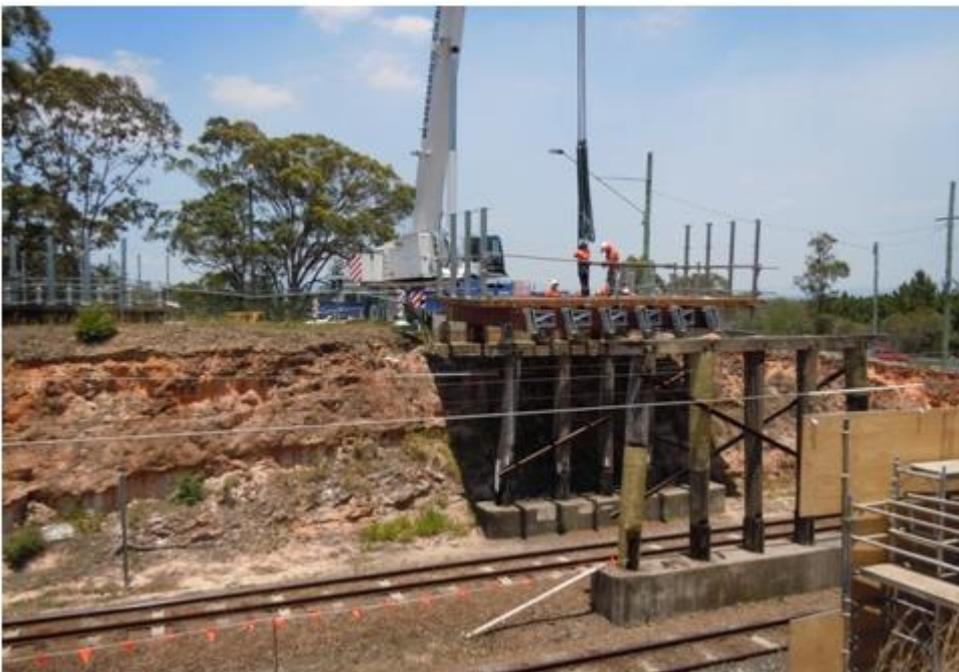
Span 1 was lowered into place using a crane.

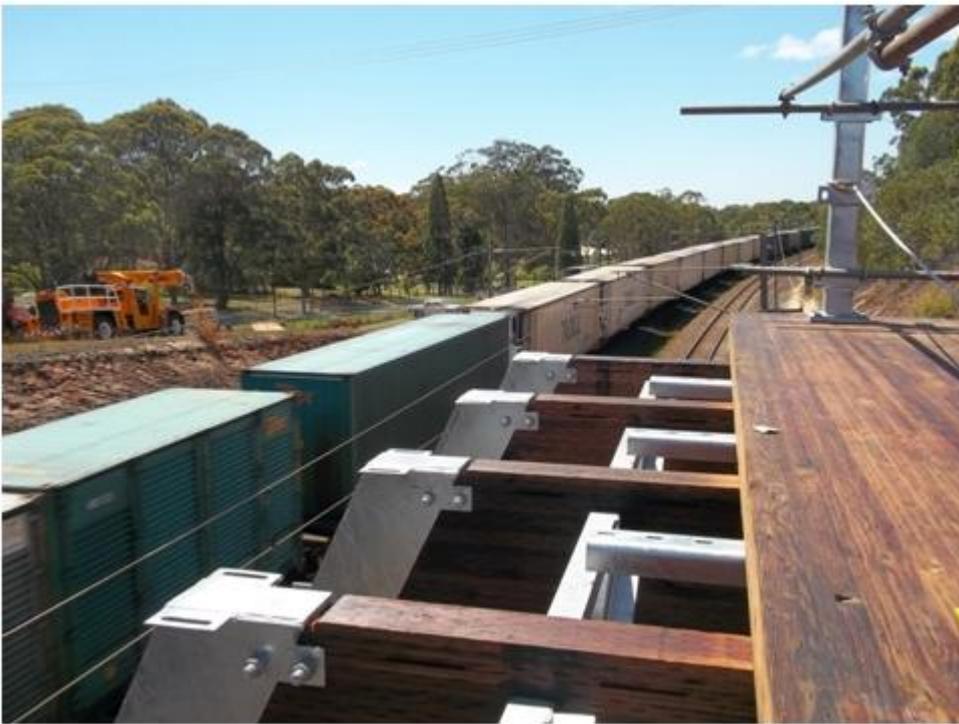
By preassembling the spans on the ground adjacent to the bridge, they could be dropped in place quickly, greatly reducing the impact on rail traffic.

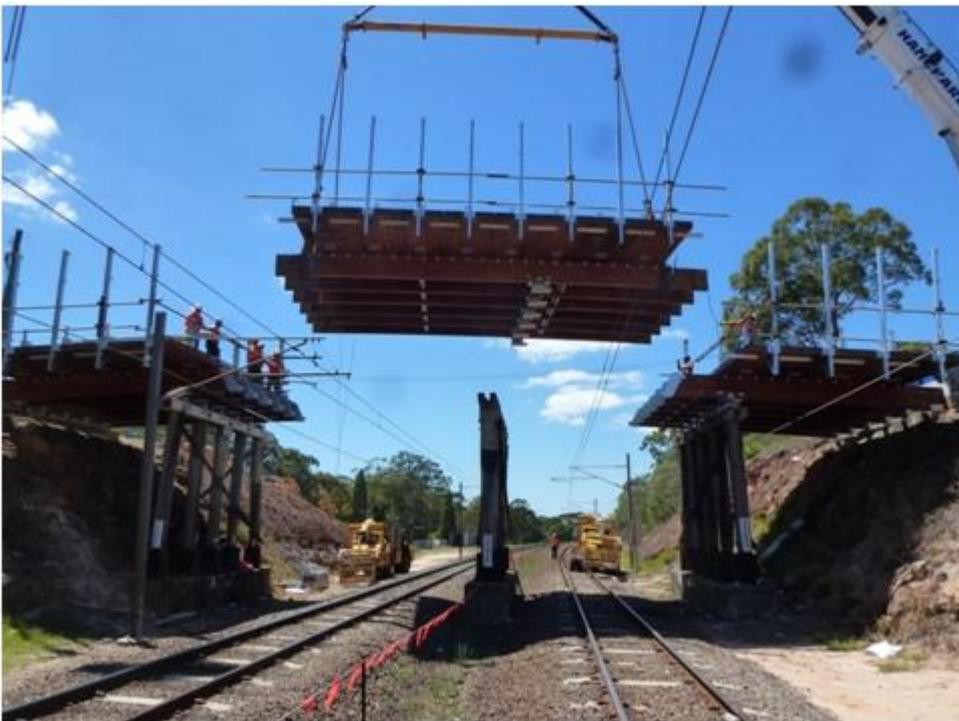
The final span was lowered into place over the tracks.

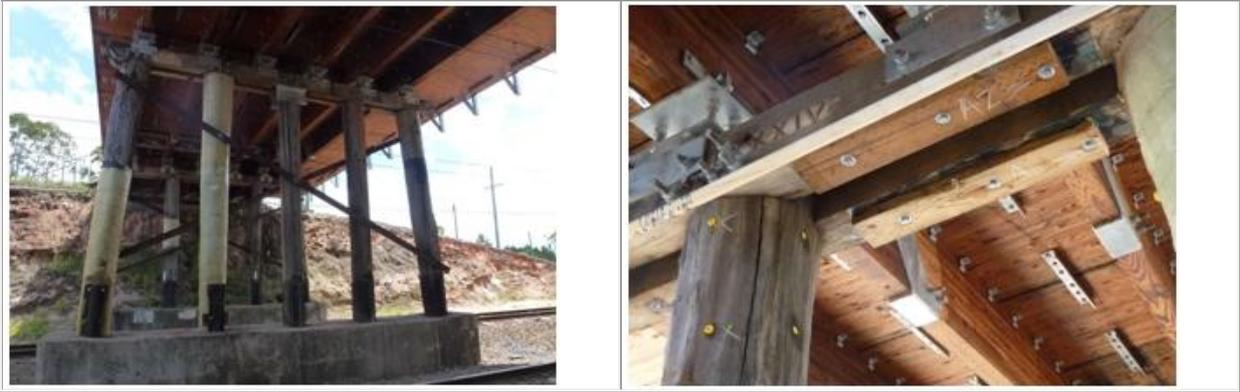
Restored pile bents are shown here with high strength fibre wraps. The yellow bungs are the locations where piles have been diffused with sodium-borate based wood diffusers which are moisture activated to release when the moisture content of the timber rises above the point at which decay will start. Crossheads were reinforced with Retroten® high-strength fibre reinforcing to increase their bending strength. The pile to crosshead bolt connections were upgraded to the standard for T44 loading by increasing the number of horizontal connectors.

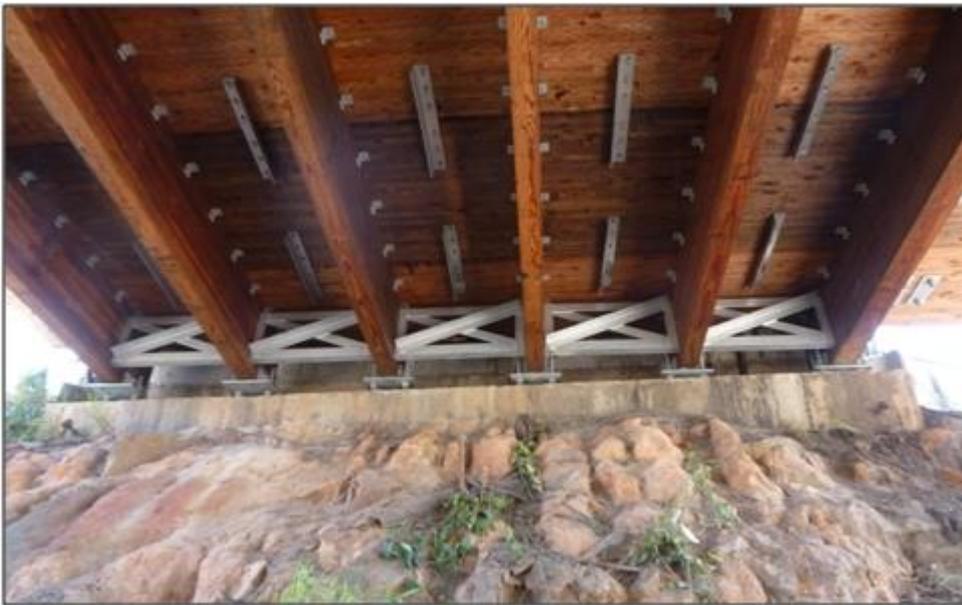
The existing concrete abutments were used to support the new superstructure.

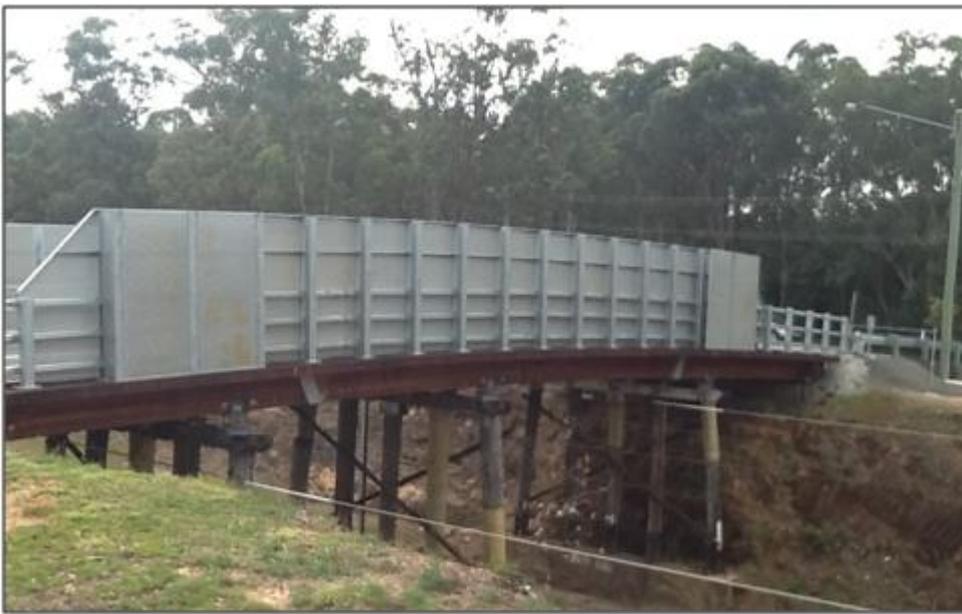
The finished bridge, with guardrails installed and paving complete, is now open to traffic without load limits. Rehabilitating the existing substructure and replacing the superstructure with lightweight glulam components that could be prefabricated and then quickly lowered into place provided significant savings not only monetarily, but in a single weekend scheduled passenger train closure period. Freight trains still operated during the installation weekend. The project was completed in two available three day work windows centered around previously planned track closures; the first closure was used to retrofit the substructure and the second closure to install the new prefabricated superstructure. The new superstructure was installed in just 42 hours. During this time 12 trains passed under the works causing a suspension of works such that the new superstructure and deck was installed in a net 32 hour window. The new penta treated glulam system has a 100 year rated life time, rivalling that of a new concrete bridge, and is able to carry T44 traffic. All of this was accomplished at approximately 1/6th the cost of

replacing the bridge with a new concrete structure since the old abutments, piers and substructure were able to be upgraded and remained in place. The new glulam bridge weights 1/8th the weight of a new concrete bridge. This weight savings is enough to allow the old substructure to easily carry the T44 loads. The new glulam bridge is 1/3rd the dead weight of the old hardwood timber bridge. The new bridge is also 16 times more carbon friendly than a reinforced concrete bridge.

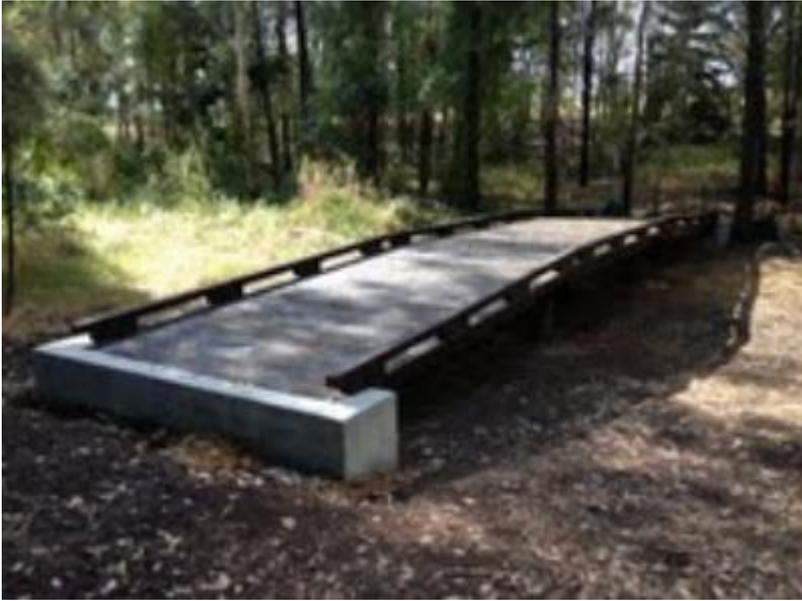
We supplied and arranged certification for a small boardwalk kit measuring 12.3x2.6 m to Myles Harm of H&G Contractors (07 3288 8609) very recently. It was reported back that when the inspectors from the council came out they were very impressed. One apparently commented, "This would have to be Ted's decking". There is a difference that discerning specifiers and purchasers should be seeking out (even though strictly speaking it is Chris's decking). Even in a small boardwalk, detailing is still crucially important. Note the abutment with back and wing walls.
