Morayfield Deck Collapse Interim Report

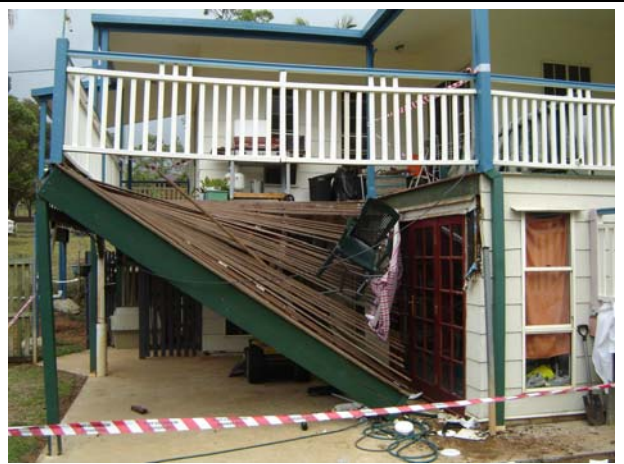
The deck collapse was due to totally decayed corner studs (probably untreated radiata) supporting the deck bearer end in the wall frame which in turn was supporting a newer deck added during extensions.
