<p>Outdoor Structures Australia Practical solutions that enhance community design projects</p> <p>Old College Road, Gattton, Queensland, Australia PO Box 517, Gattton, Queensland, Australia, 4343 Ph: (07) 5462 4255 Fax: (07) 5462 4077 Email: ted@outdoorstructures.com.au Website: www.outdoorstructures.com.au</p>		Date	Description	
		29/01/2003	OUTDOOR STRUCTURES AUSTRALIA INSTALLATION INSTRUCTIONS STANDARD BOLLARD	
Drawn	Scale	Job No	Drawing No	
E.M.S.	N.T.S.	OSA	TBPBI	
Approved				
E.M.S.

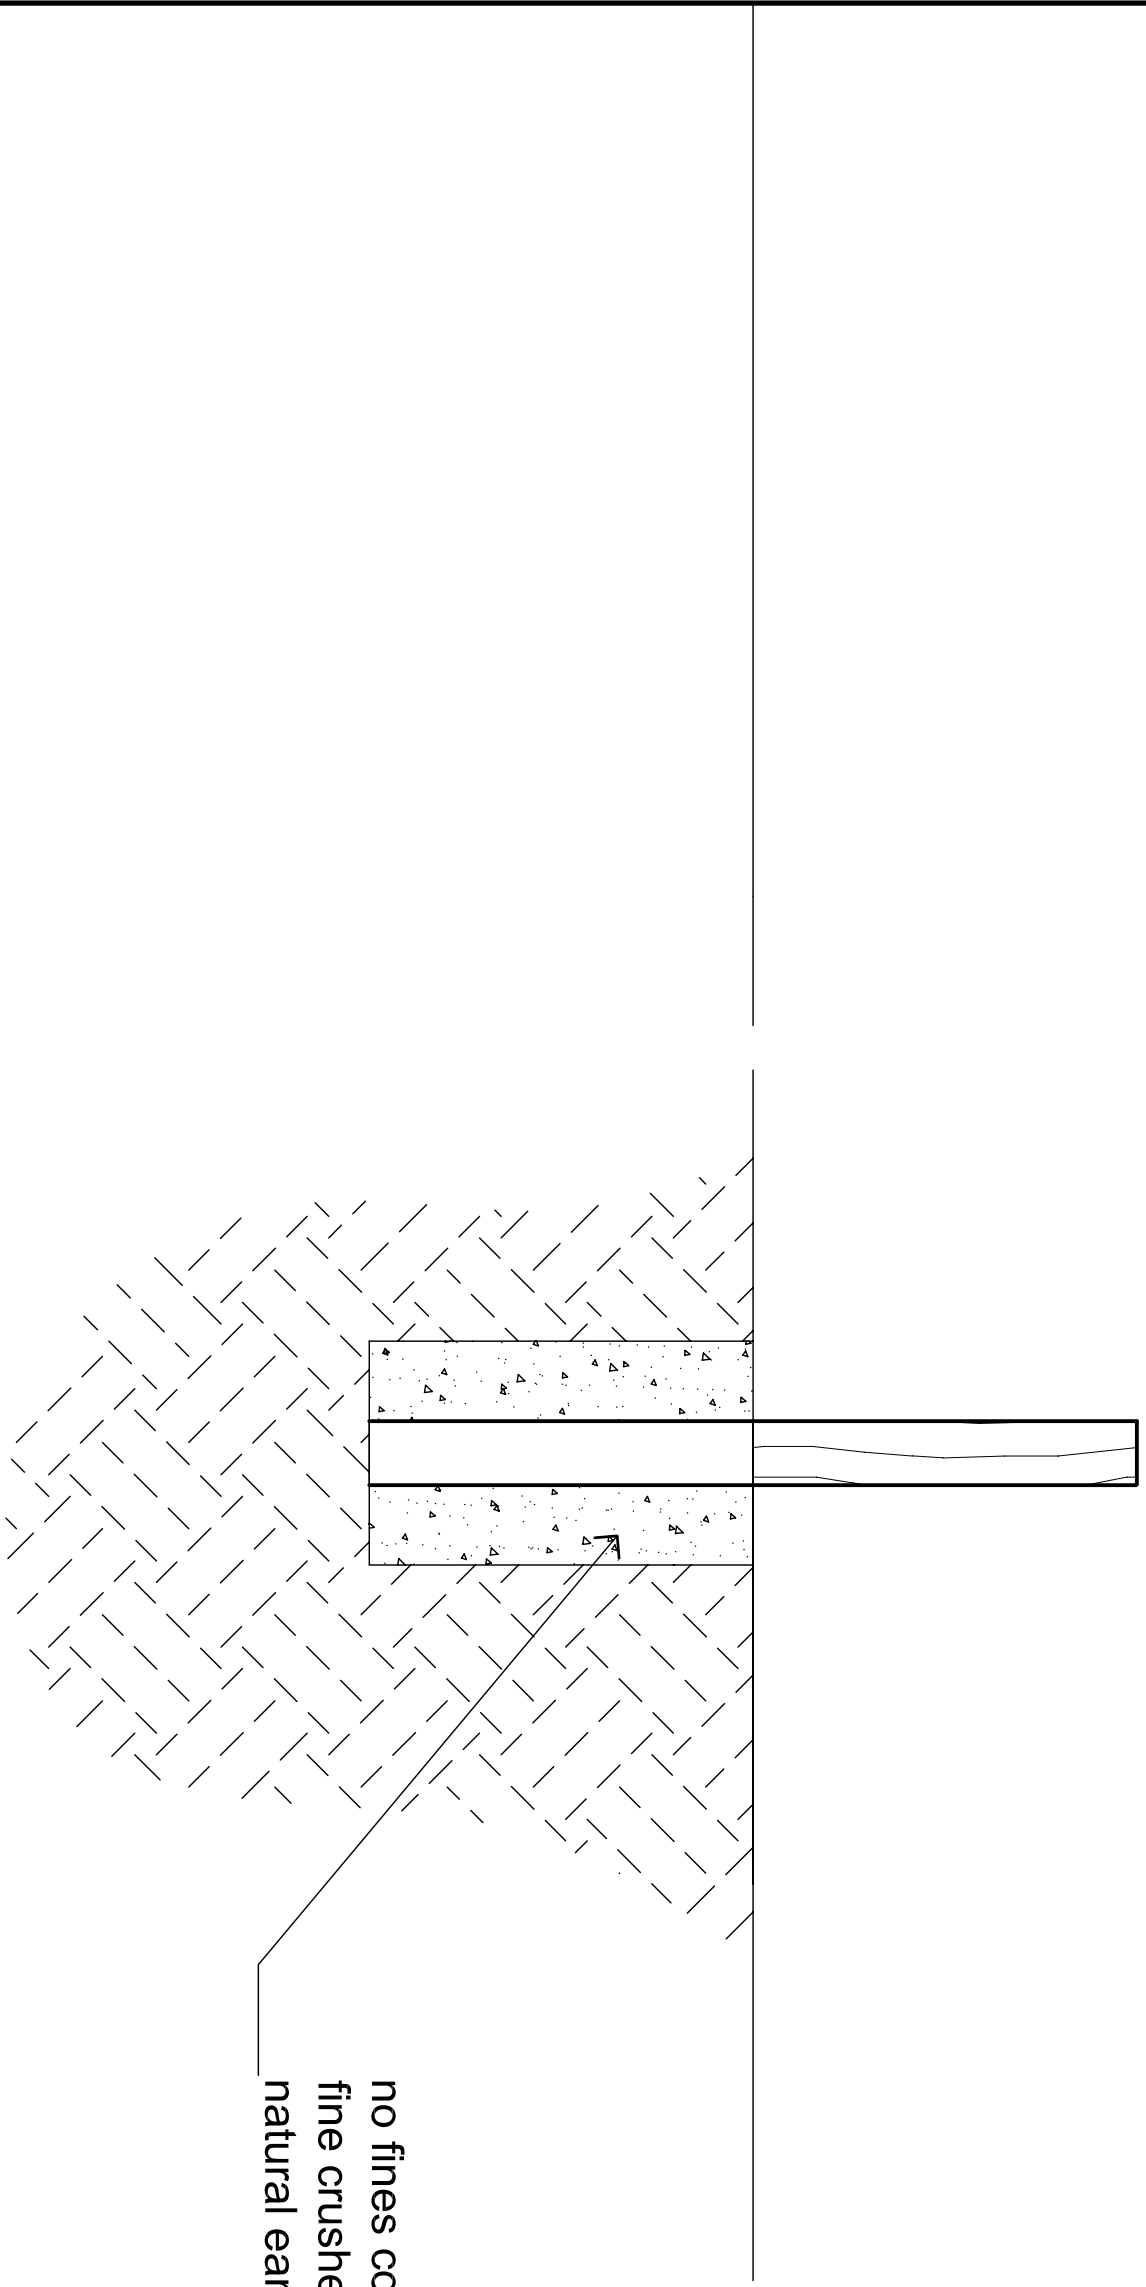
no fines concrete
fine crushed rock
natural earth

**SLOPE ON TOP OF POSTS AS DIRECTED BY CLIENT
NORMAL ALIGNMENT IS WITH THE SLOPE TO THE FRONT**
