February 2010 Newsletter

Decks can kill!

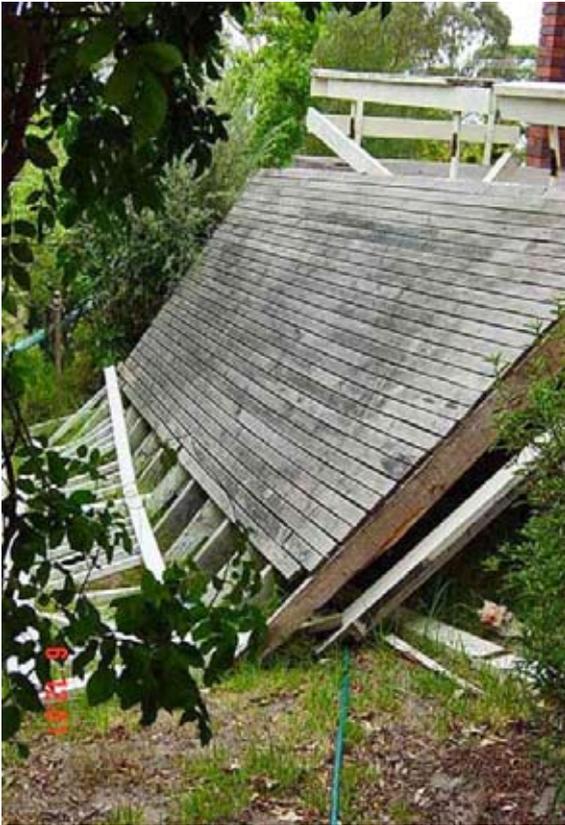
Image from Archicentre press Release

The pictures show the terrible impact of *she will be right* design and use of the wrong timber. According to the Archicentre there could be as many as 8,000 of these **potentially fatal** balconies or decks throughout Australia. Archicentre are not talking about sub-standard decks but life threatening decks!! To help you identify if your deck is at risk we have provided links below to reports on collapsed decks - as the last thing we want is for your deck to make headlines.

The Archicentre press release highlights the problem of inappropriate timbers in deck construction. Most have come to terms with no longer using Oregon pine in their construction but some people are still using Durability 2 Above Ground timbers (generally an old Durability Class 3 species). The end result is the same; it just takes longer to happen.
