## March 2014 Newsletter

Written by Ted Stubbersfield

### [Hardwood at Groundline](#)

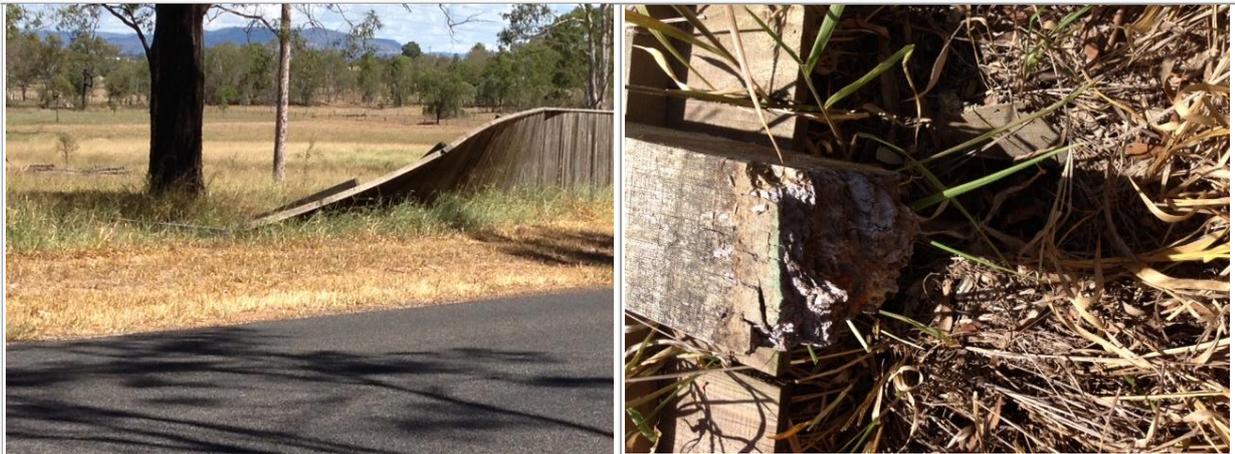
I was out driving with my wife on Sunday when I noticed this fence that has fallen over. It is no more than 10 years old, probably less. The posts are hardwood and of course they are set into concrete which then decayed at groundline and simply snapped off. The posts are hardwood but that does not mean much if the lowest priced tenderer did not pay extra for the better performing timber. But at the end of the day purchasing the better hardwood will not prevent, just delay the inevitable. Hardwood and concrete do not mix, It makes no difference if sawn timber is treated or otherwise. How do you do it correctly? [Follow this link See also the March 2011 Newsletter.](#) Knowing how to put a post in the ground is not "secret men's business" but is basic knowledge every tradesmen is paid to know.

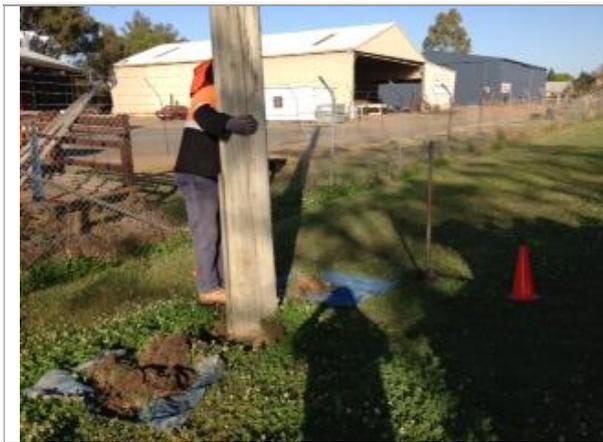
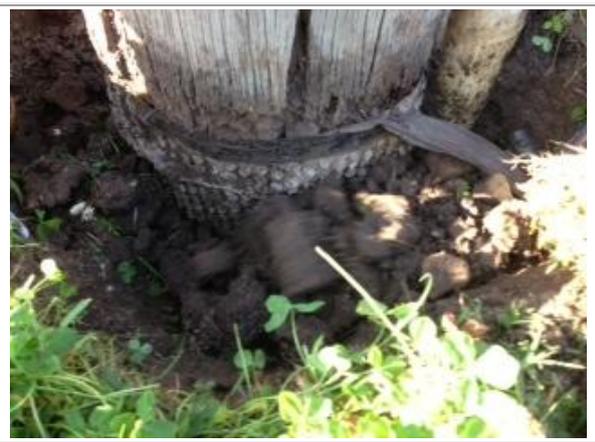
Ground  
line

Maintenance is still being conducted and these two images show it being done to a pole outside of our premises. This happens every five years and the shrink wrap bandage has now been replaced with a loose fitting bandage with boron pellets. Strangely, it appears that the wrap is not installed when the pole first goes in the ground before any decay has taken place.

How effective is this maintenance? It really isn't known what the service life of a power pole actually is. It is thought to be 40 years. The difficulty is that a powerline is generally upgraded and the poles replaced with larger ones before they have to be removed due to failure. This mucks up any statistics.. Groundline maintenance is amplified upon in my Timber Preservation Guide.

So, even if you have been careful and not used concrete you still need to maintain a H5 CCA pole at ground line. There is a lot to be said for upgrading critical poles that will not be maintained to H6 but then, with pigment emulsified creosote you do not want to be touching them.

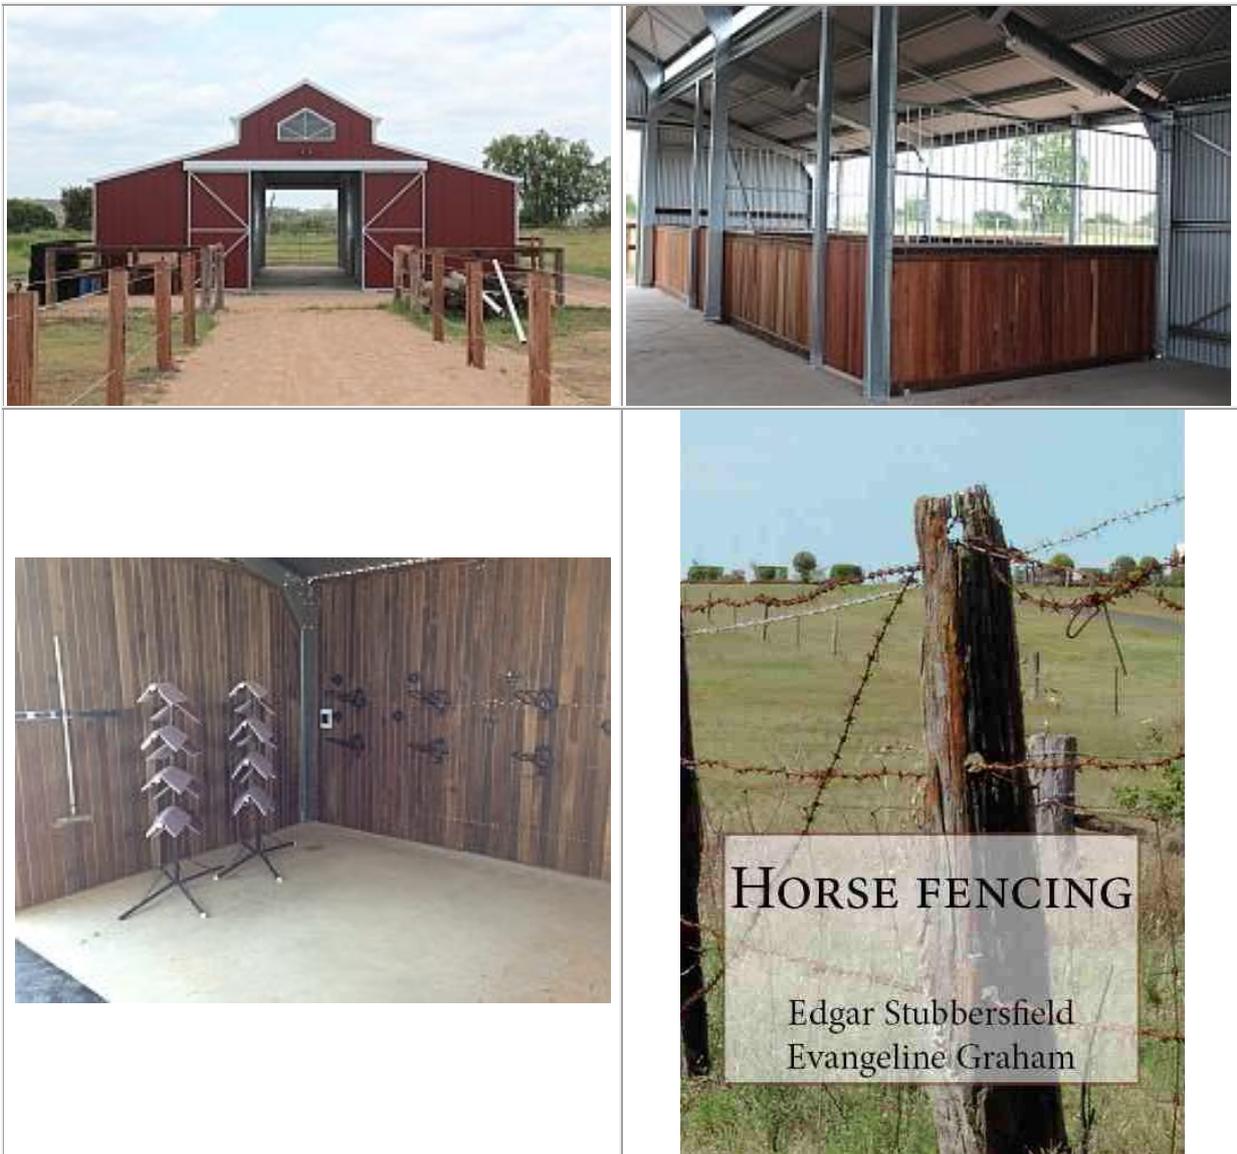
A projects that Chris completed late last year was to supply material and assembled doors for a stable built in Gatton. This stable block is built within a more or less standard kit metal shed. The rails on the stalls were 125x50 spotted gum and the slats were 88x19 spotted gum decking. The walls were downgrade life plus, by downgrade, I mean to our standards. I particularly like spotted gum for horse and cattle yard rails as it is unlikely to shatter if an animal hits it hard. This resilience is why spotted gum is recommended for handles in striking tools.
