OUTDOOR STRUCTURES

April 2013 Newsletter

[Lessons from a Failed Boardwalk](#)

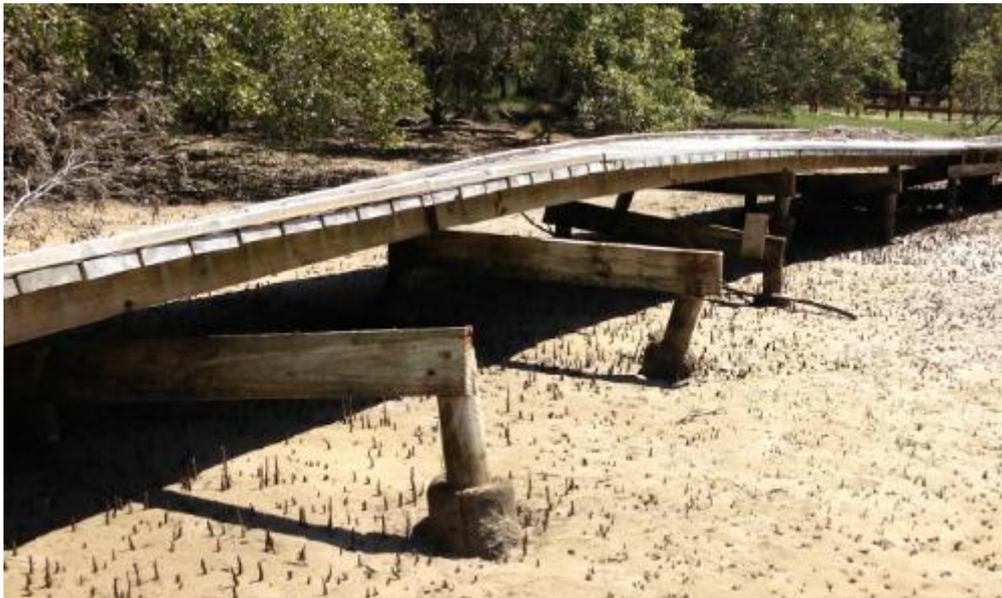
Last month one of my readers emailed me saying that I should go to a certain location and photograph a failed boardwalk as my readers could learn a lot from it. He was right, there was a lot to learn as here, the theory in my guides gets put into practice, or more correctly doesn't get put into practice. Do you have my guides in your library yet. I suggest it would be worthwhile as you will see in the topic "F14 - You Deserve Better" below.

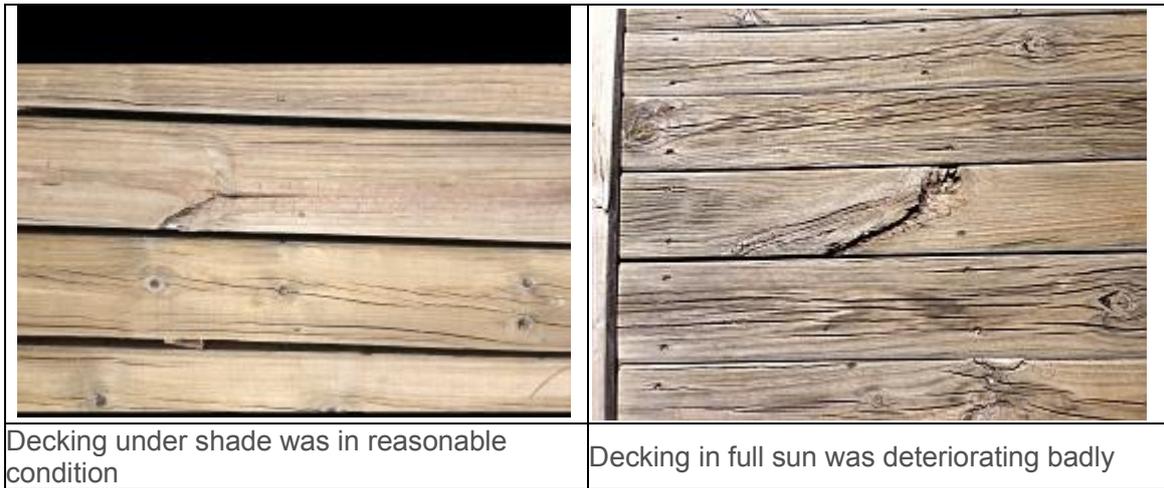
The most obvious thing about this boardwalk, apart from the fact it is broken is that it is made from treated pine. This boardwalk was built at a time when people incorrectly thought that to be environmentally responsible we had to use timber cut from a sustainable pine forest, after all it came with a 40 year warranty. But people didn't consider that the only way you had an exotic pine forest was to bulldoze a perfectly good native forest, leaving in its wake a wasteland as far as native animals were concerned. As well, people filed away the guarantee with the job documentation without checking what the treated pine was actually guaranteed for. Refer to my Timber Preservation Guide for a discussion of warranties on treated timber.

To be fair, where the pine decking is under cover it is fine but, in the Queensland weather (i.e, "weather on steroids"), it is self destructing, and it could do nothing else. Fortunately I do not see pine boardwalks being built in Queensland now. As far as environmentally responsible use of hardwood is concerned, the Boardwalk Design guide shows you how to design in a sustainable way with timber produced under the SE Qld Forests Agreement.

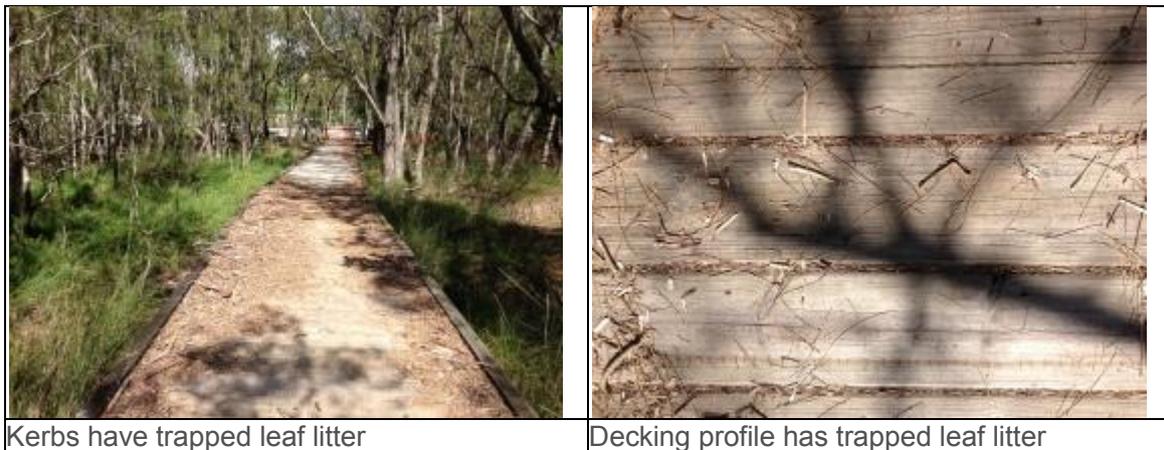
Deck is not self cleaning

The Outdoor Structures boardwalk system is designed to be self cleaning. We achieve this, in part, by raising the kerb above the deck to let litter clear. The patented Deckwood profile completes the system allowing leaf litter to just drop through.

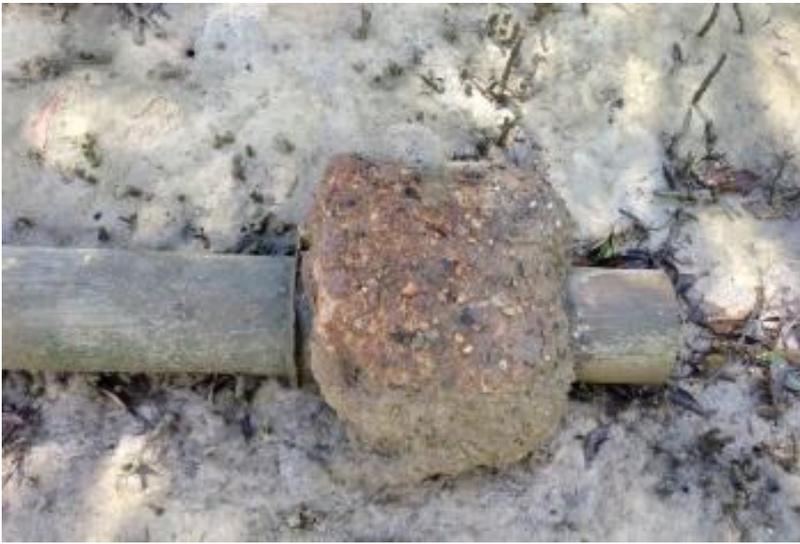
Foundations are simply inadequate here. In this application, beside a tidal creek, we would have used a driven pile. But is it correct to use a H5 treated pine post in this marine application? Back when this boardwalk was built, the Australian Standard may have allowed it. It is a pity it did not work and they had to amend the standard with the clause starting "Experience has shown...". Our Boardwalk Design Guide explains how to ensure a pine post works in a marine environment. Now you might say, this post looks fine, but design should be about certainty, not luck. If the foundations were correct a new boardwalk could have been built on them as you should expect 50 years from this foundation material if used correctly.

I can only imagine the difficulties trying to install a potted post when there is a high water table.

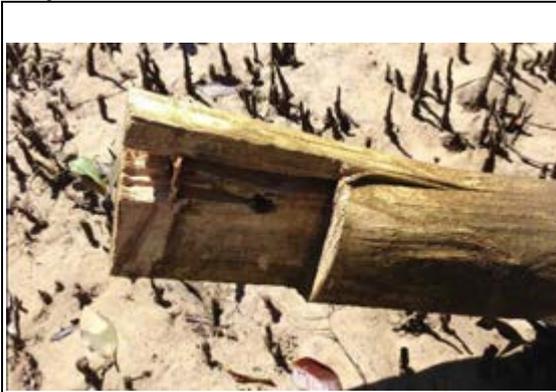
The end clearances were not maintained on the post tops and on some of the bearers. When designing a boardwalk it is important to incorporate into the post layout the reality that they may not be placed very accurately.

Bolts too close to the post top

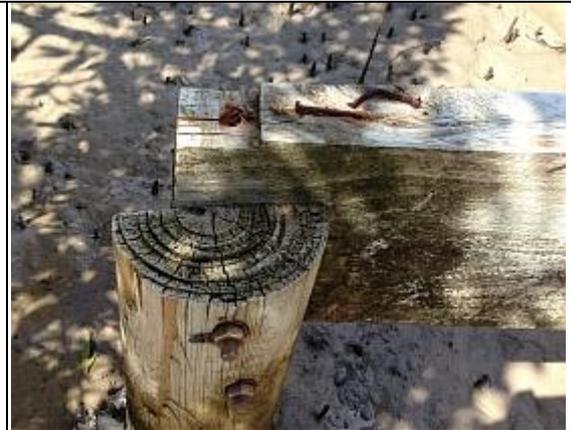
Bolts too close to the bearer end

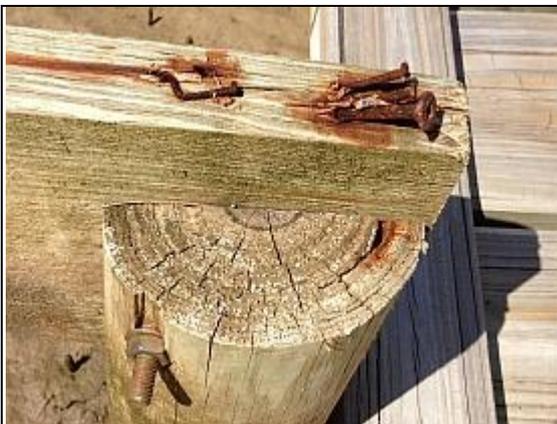
It is no wonder that the boardwalk is laying to the side as the joists were simply nailed to the bearers. I assume that the nails were galvanised, but readers, they do not work, neither do galvanised bolts. As they rusted they expanded splitting the timber.

Joists were only nailed on

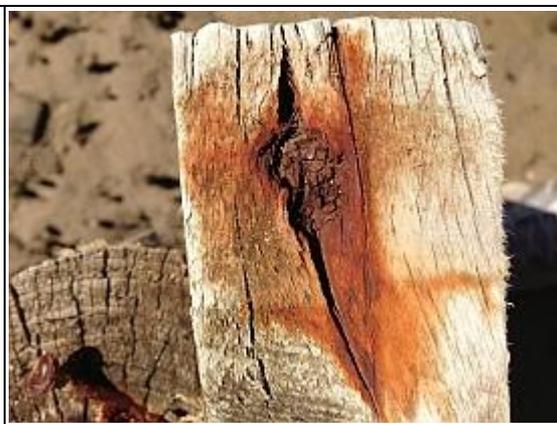
Rusting nails have damaged the timber

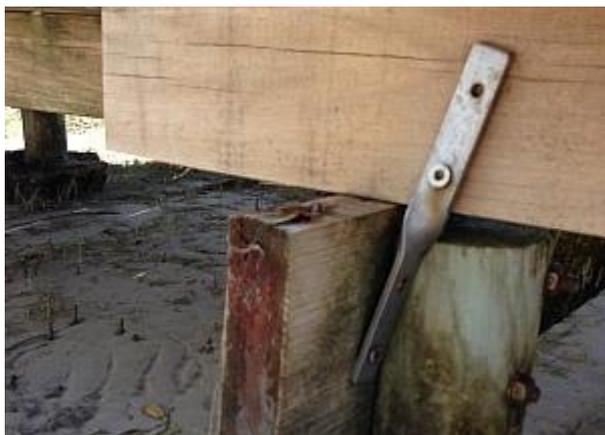
Where there have been new sections installed some stainless brackets were installed instead of nails but for some reason the builder didn't install the second screw making the bracket ineffective when required to work. That is why inspections are important.

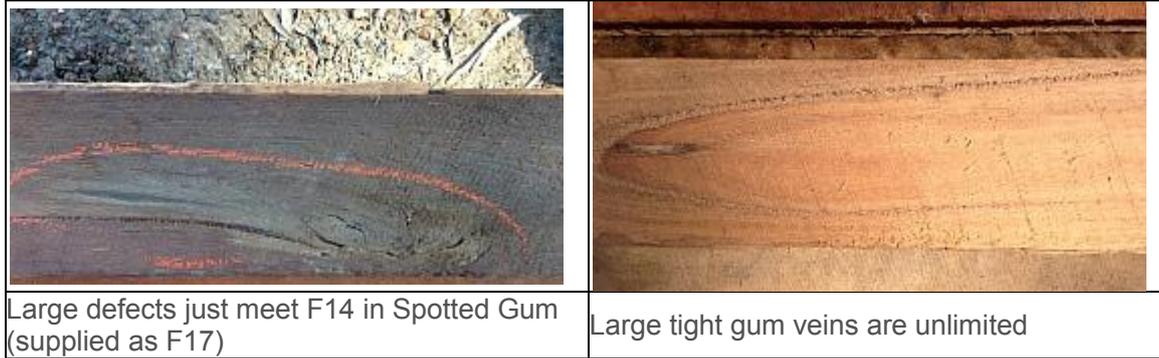
A knot less than 1/3 of the width of the board, and/or
Loose gum veins 1/4 of the length of the board, and/or
Tight gum veins unlimited and/or
Wane & wane 1/4 of the cross section of the board

Here are some photos

The timber in the images did at least have the right natural durability but not the right quality. But with just an F14 specification you can be assured that you will not have the durability as the better species are more expensive) and you are not likely to have the right quality. In blackbutt, (unsuitable for this type of work and what they will probably end up with because it meets the inadequate specification, is in ready supply and is at the cheaper end of the hardwood price spectrum), it represents timber with 48% of the strength of timber free of defect, and for ironbark it is only 38%! All these defects quickly deteriorate in the weather.
